**ADDENDUM NO. 1
RFP No. 2022-12-01
LEASING AND DEVELOPMENT
MIAMI SHORES VILLAGE OWNED REAL PROPERTY
10500 NW 17th Avenue, Miami, FL 33147
January 23, 2023**

METHANE GAS MONITORING

**Village of Miami Shores Public Works Complex
1701 N.W. 103rd Street
Miami-Dade County, Florida
DERM: SW-1423/File-13200**

RE: **Methane Gas Monitoring Report**
Village of Miami Shores Public Works Complex
1701 N.W. 103rd Street
Miami-Dade County, Florida
DERM: SW-1423/File-13200
Project Number: HA06-2114

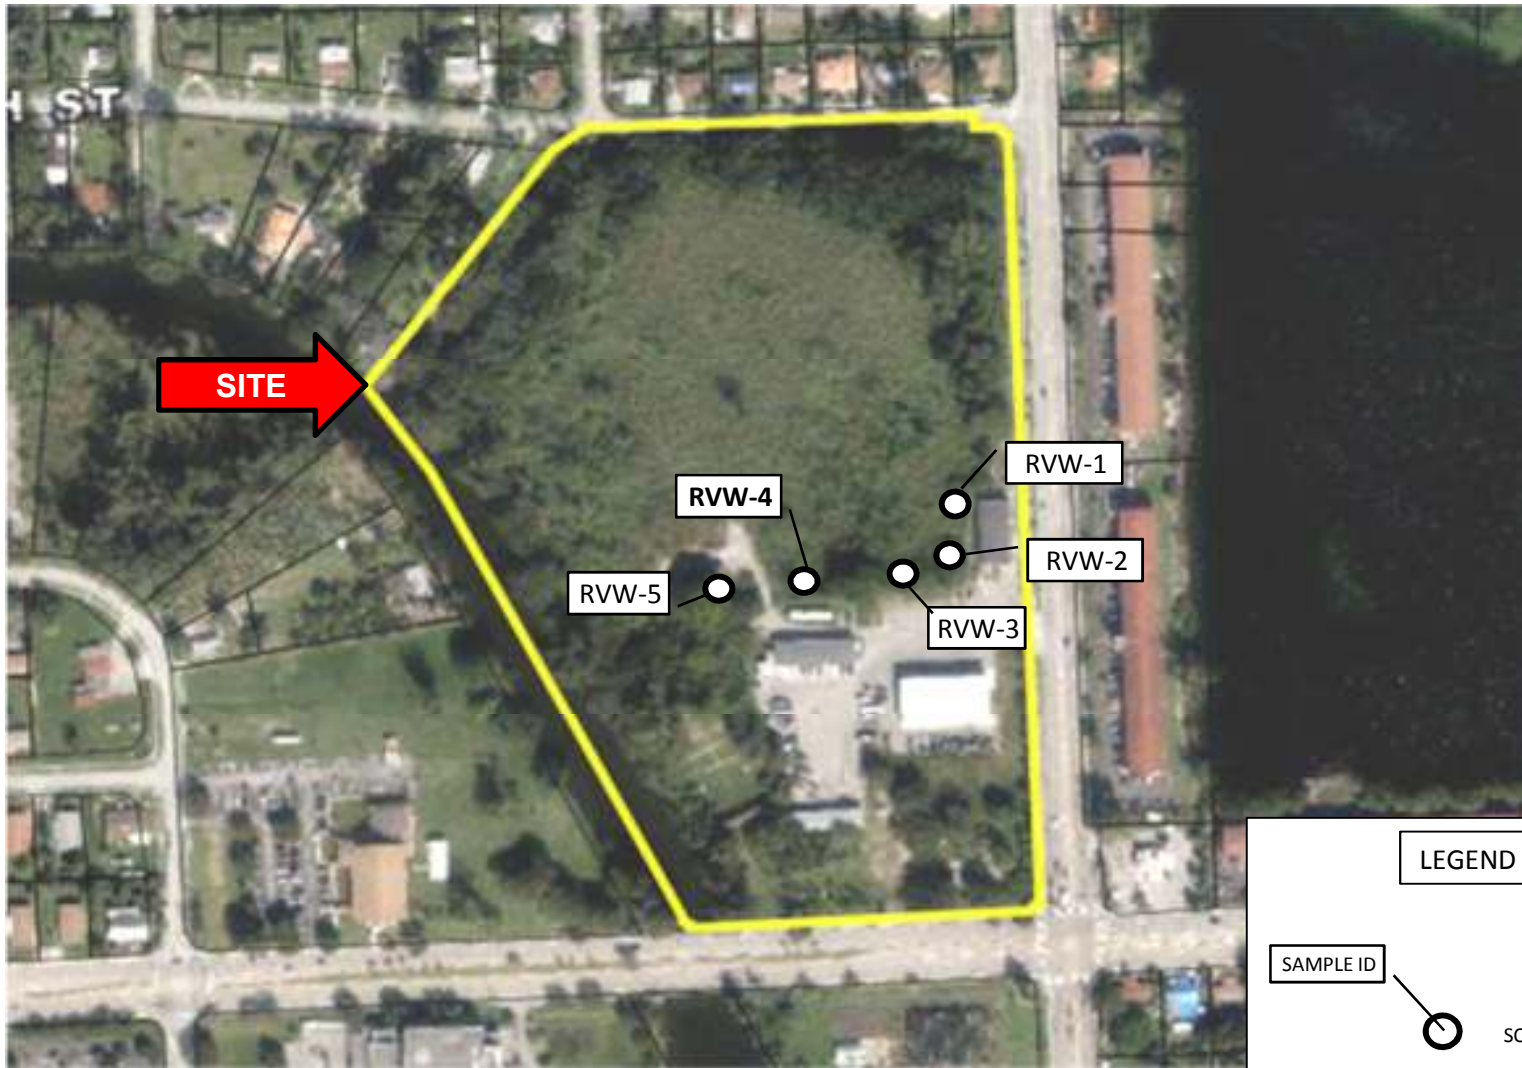
FIG 2

On July 22, 2022, HAI obtained readings from five (5) dedicated soil monitoring probes throughout the site. The approximate location of the probes is depicted on the attached Figures. The monitoring probes extend vertically across the vadose zone, to above the groundwater table and had a screened portion to obtain representative gas data from the vadose zone. The monitoring probes were designed to prevent the intrusion of atmospheric air at all times. This was achieved by equipping the monitoring probes with an air-tight sampling port with a direct attachment for the gas sampling instrument. Static methane readings were collected and recorded in our data as a percent of the Lower Explosive Limit (LEL) and also by percent volume of total gas. In addition, steady state methane readings were collected and recorded for each sampling point. During the sampling event, the sampling pump and meter remained connected for a minimum of five minutes until one pore volume had been evacuated and until the readings reached steady state as indicated on the attached data table. HAI collected measurements from the methane probes using a Landtec Gem 2000 field gas analyzing meter. Copies of the GEM 2000 calibration logs for the monitoring conducted on July 22, 2022 are included in Appendix 4.3. HAI monitored the methane probes for percent carbon monoxide (% CO²), percent oxygen (% O²), percent methane (% CH⁴), percent of the lower explosive limit (% LEL) and pressure (inches of mercury {Hg}). The lithology of the soil at the monitoring probe location consisted of clean fill material. The most recent data results are summarized in the attached summary table included in Appendix 4.3.

2014 Aerial

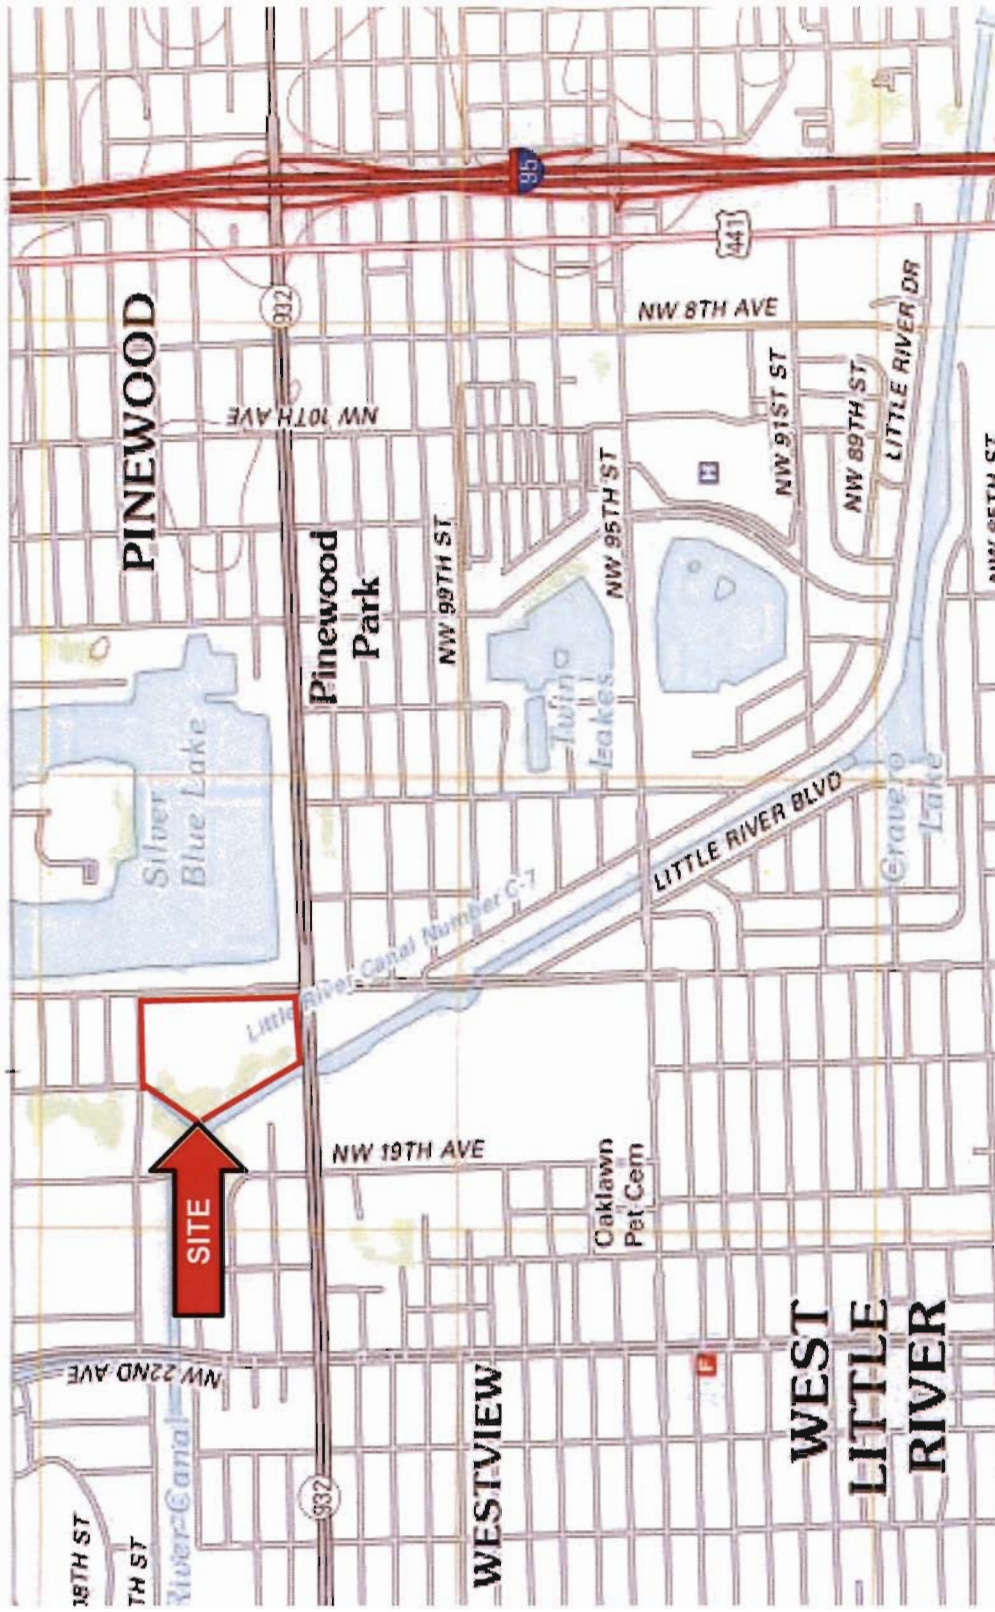
On December 17, 2014, HAI personnel conducted soil vapor monitoring of vapor wells RVW-1, RVW-2, RVW-4 and RVW-5, to fulfill this Quarterly Sampling Event. RVW-3 could not be found during the sampling event. Table 1 summarizes the methane gas soil vapor monitoring, and Figure 2 shows the vapor well locations.

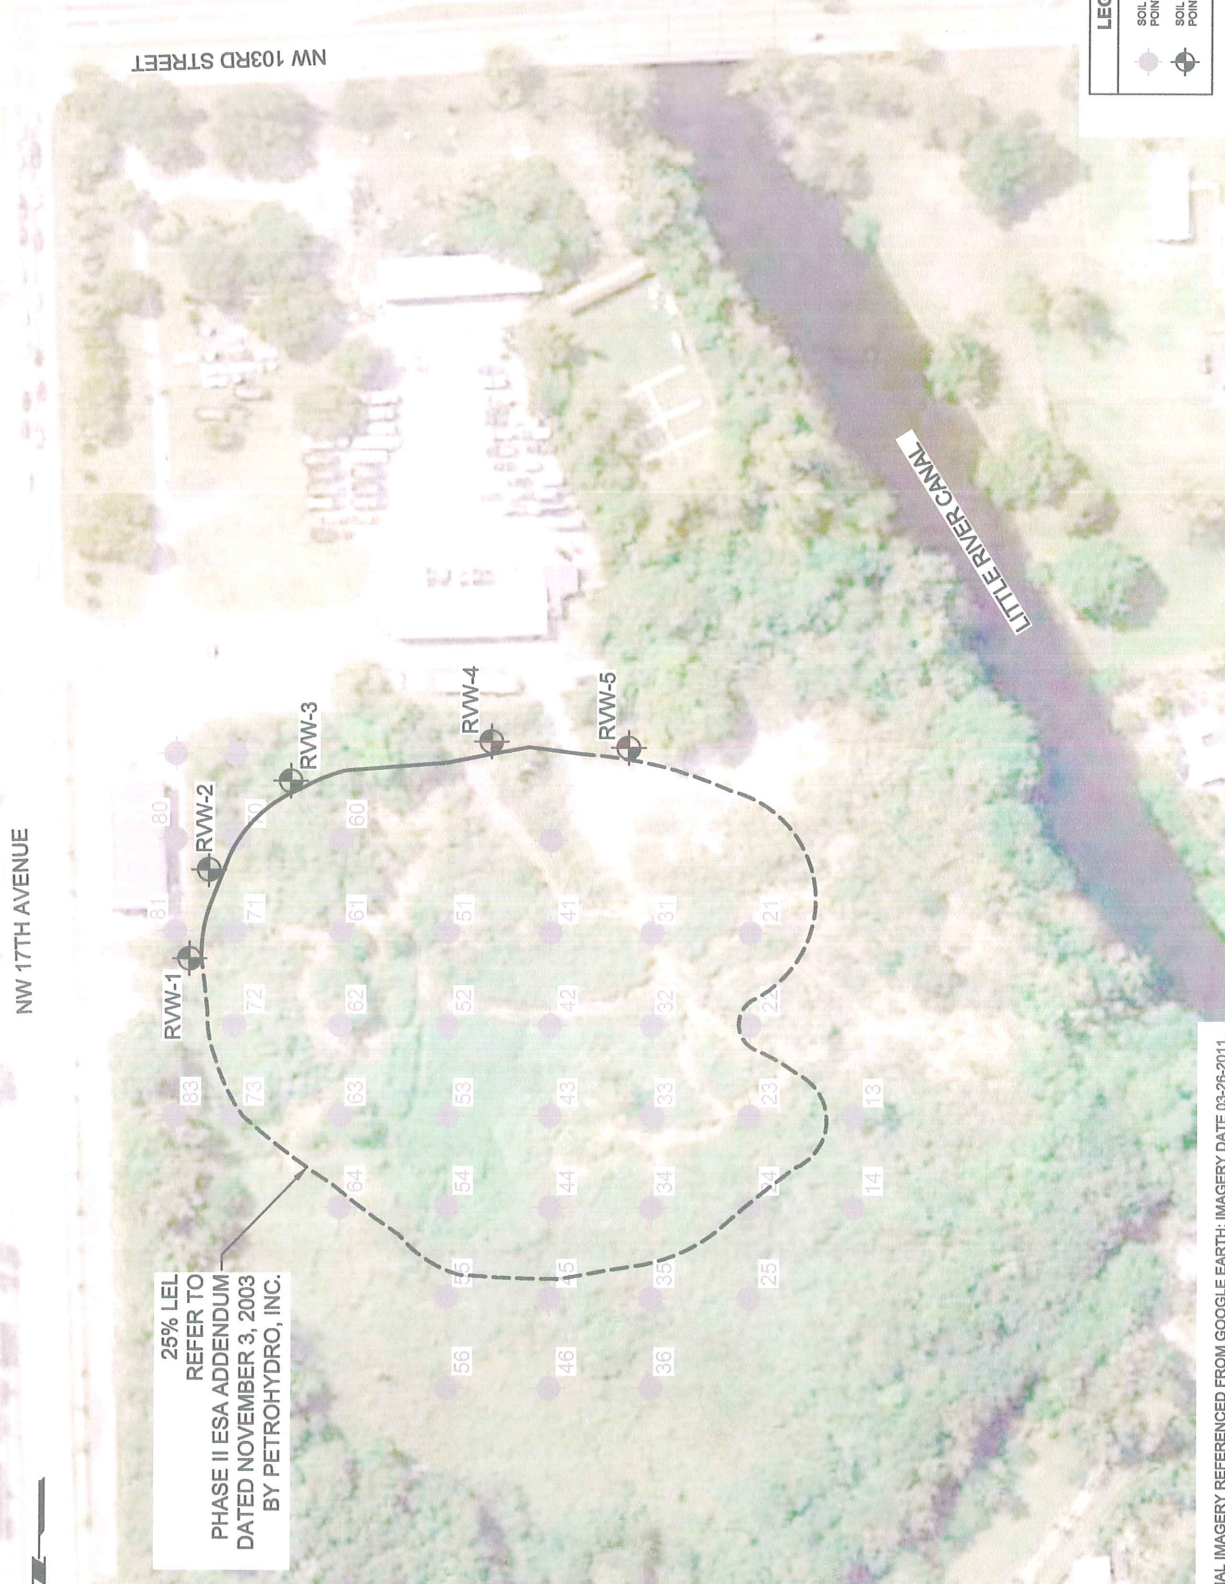
NW 107TH STREET

LITTLE RIVER CANAL

25% LEL
REFER TO
PHASE II ESA ADDENDUM
DATED NOVEMBER 3, 2003
BY PETROHYDRO, INC.
